HUDSON RIVER BASIN  
PAPAKATING CREEK TRIBUTARY  
SUSSEX COUNTY  
NEW JERSEY

# LAKE NEEPAULIN DAM NJ 00282

## PHASE 1 INSPECTION REPORT NATIONAL DAM SAFETY PROGRAM

August, 1979

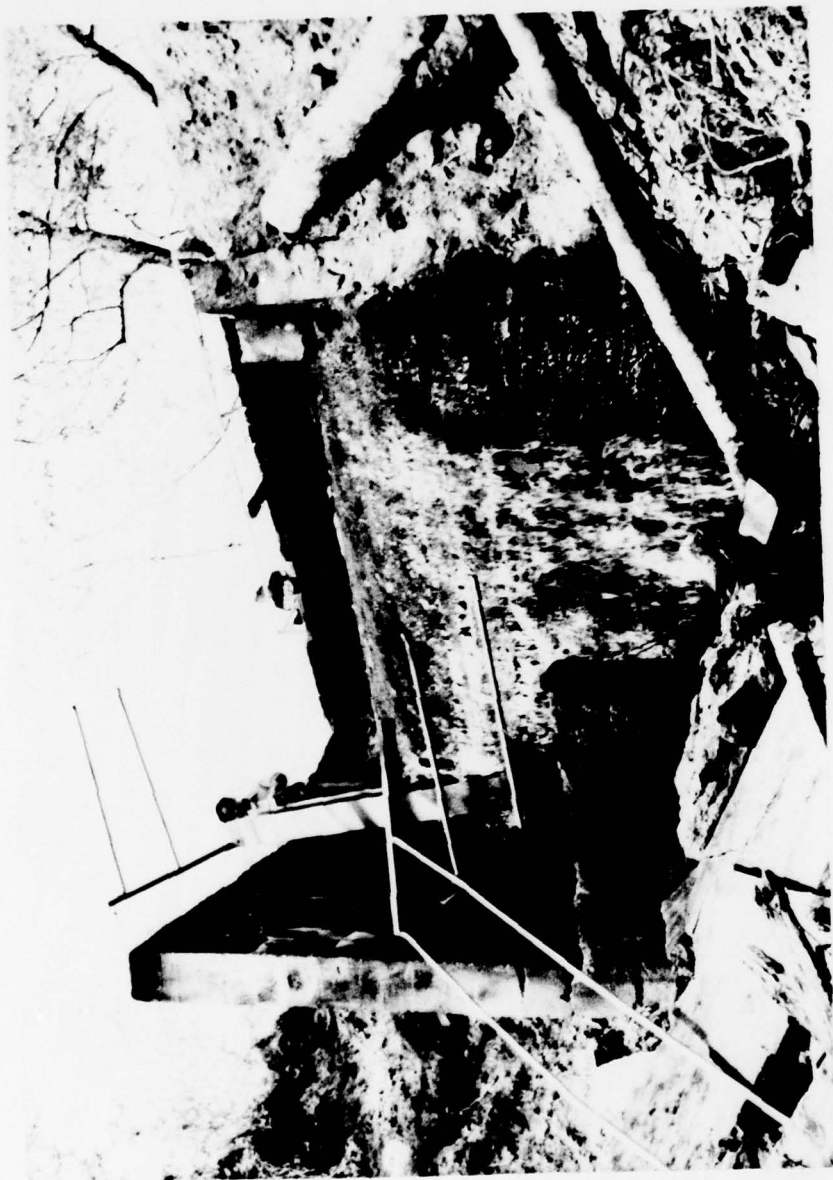
Lake Neepaulin Dam  
View of spillway, downstream face.

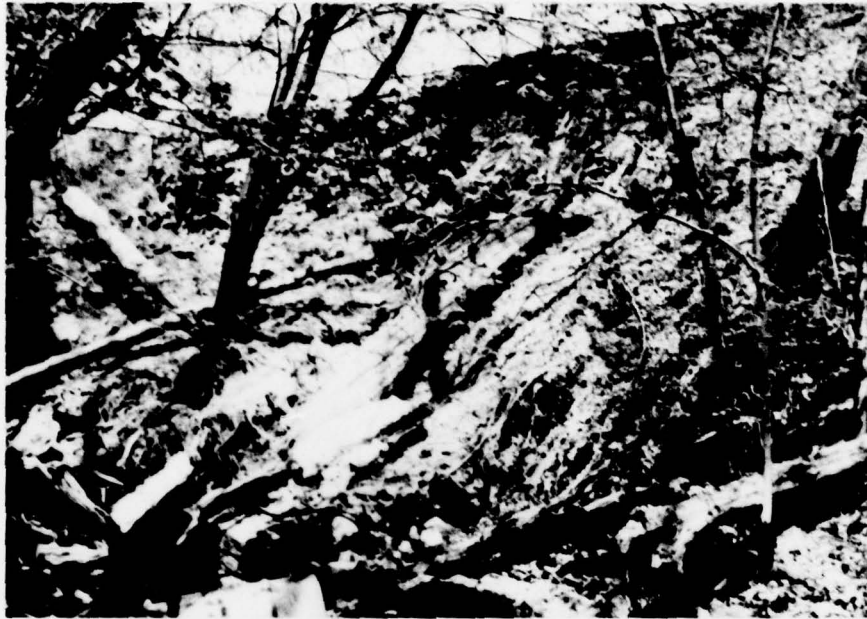
The dam embankment does not appear to be stable. The downstream face has a 1H:1V slope. The left embankment is severely eroded at the downstream face next to the spillway, to a nearly vertical slope along the top 11 feet for 25 feet of length. Similarly, the face of the upstream embankment, above the lake surface is on a 1H:1V slope and no rip-rap protection was placed on this face. However, no cracking is visible anywhere on the embankment, and no misalignment has been noted. On top of the upstream face, trees are growing uncontrolled to 8-inch diameters. Brush and trees, to 9-inch diameters are also growing uncontrolled on left and right downstream embankment faces.

Photo No. 3 - View of left downstream face near spillway showing severely eroded embankment slope and fallen trees. Note also the retaining wall at toe.

1. The embankment material that has been eroded from the downstream face, particularly adjacent to the left wingwall of the spillway, should be replaced with quarry-process stone or gravel. Slopes should be reconstructed with keying and compaction of material to improve stability and to support the abutments and wingwalls. Slopes should be as determined by the stability analysis, and should be protected with rip-rap near the spillway. This work should be undertaken within six months.

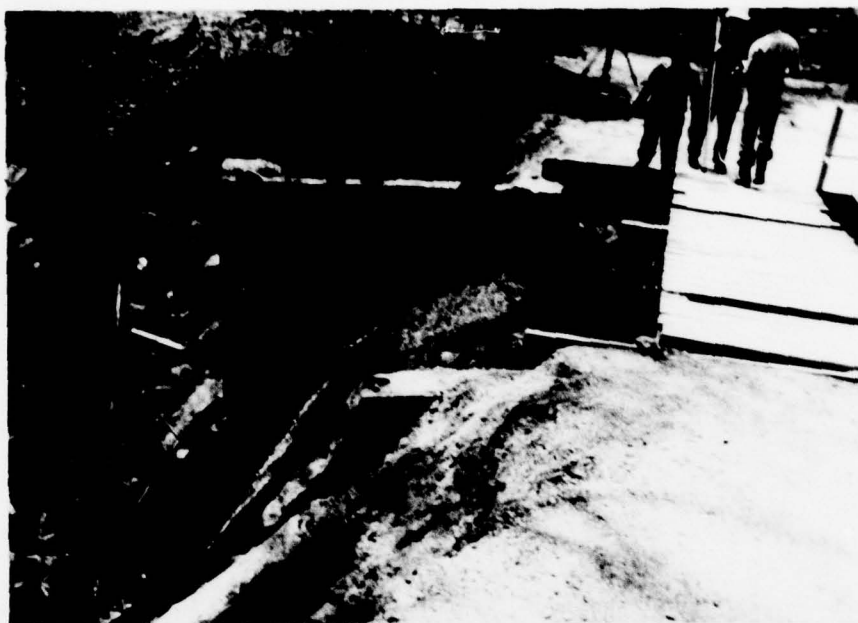
The downstream steel stringer of the footbridge has been dislodged by ice, and is resting on the spillway. Timber planking of the remaining bridge is deteriorated and the small bridge piers are cracked.

Photo No. 5 - View of top of dam showing footbridge, spillway structure, and right embankment. Note fallen stringer and hand-railing. Outlet pipe discharge is partially visible beyond right wingwall.

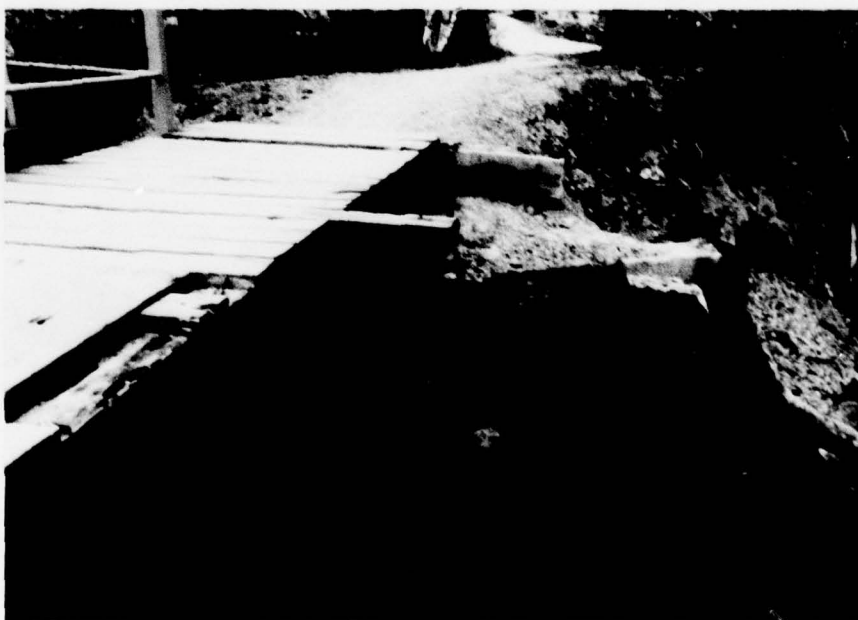
The concrete ogee spillway shows signs of surface weathering, with erosion along the construction joints. The left wingwall is broken off where it intersects the spillway surface. Erosion is visible around the concrete structure.

Photo No. 6 - View of top of dam showing spillway and left embankment. Note eroded downstream slope, spillway, the broken left wingwall and footing of fallen stringer.

3. Repair all cracked and spalled concrete with epoxy cement within six months. Rebuild the left wingwall and resurface the ogee spillway to a smooth finish.

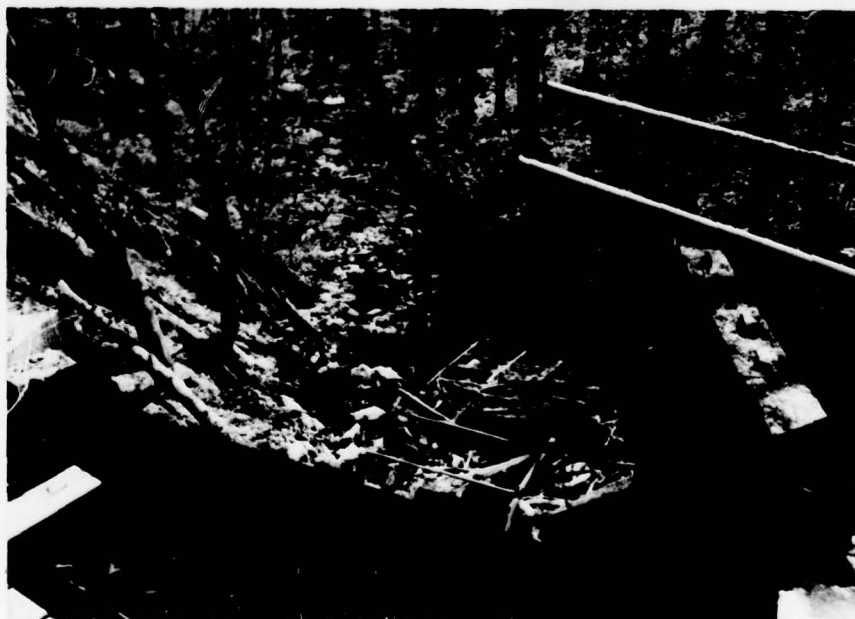
The downstream channel is shallow beyond the discharge channel and is full of debris and fallen trees. The channel flows in a V-shaped valley having 3H:1V to 4H:1V side slopes. At the discharge channel, however, the side slopes on both sides are steeper, with slopes of up to 1H:1V next to the embankment. The entire valley downstream of the dam is wooded. Minor seepage was noted in the right channel bank, approximately 100 feet downstream of the toe.

Photo No. 8 - Overall view of downstream channel from top of dam. showing spillway in foreground. Note the steep, wooded valley sides, and the debris in the channel.
